DEPARTMENT OF TRANSPORTATION

Contract #: 04-0120F4Cty: SF/ALA Rte: 80 PM: 13.2/13.9File #: 69.28**WELDING INSPECTION REPORT****Resident Engineer:**Pursell, Gary**Address:** 333 Burma Road**City:** Oakland, CA 94607**Report No:** WIR-015141**Date Inspected:** 10-Jun-2010**Project Name:** SAS Superstructure**OSM Arrival Time:** 700**Prime Contractor:** American Bridge/Fluor Enterprises, a JV**OSM Departure Time:** 1900**Contractor:** Zhenhua Port Machinery Company, Ltd (ZPMC), Changxing Island **Location:** Shanghai, China**CWI Name:** Xu Tao**CWI Present:** Yes No**Inspected CWI report:** Yes No N/A**Rod Oven in Use:** Yes No N/A**Electrode to specification:** Yes No N/A**Weld Procedures Followed:** Yes No N/A**Qualified Welders:** Yes No N/A**Verified Joint Fit-up:** Yes No N/A**Approved Drawings:** Yes No N/A**Approved WPS:** Yes No N/A**Delayed / Cancelled:** Yes No N/A**Bridge No:** 34-0006**Component:** OBG COMPONENT**Summary of Items Observed:**

WELDING INSPECTION REPORT

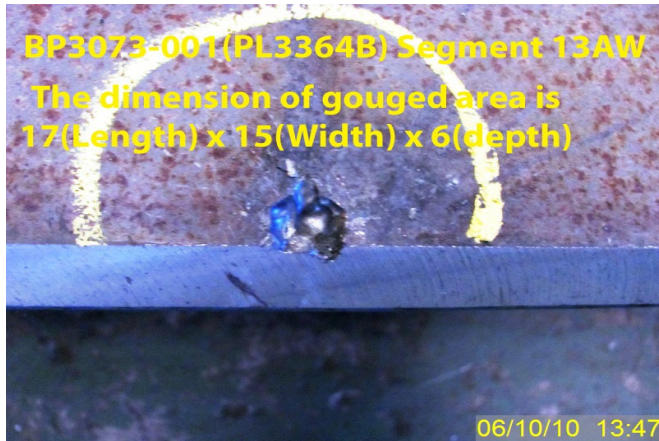
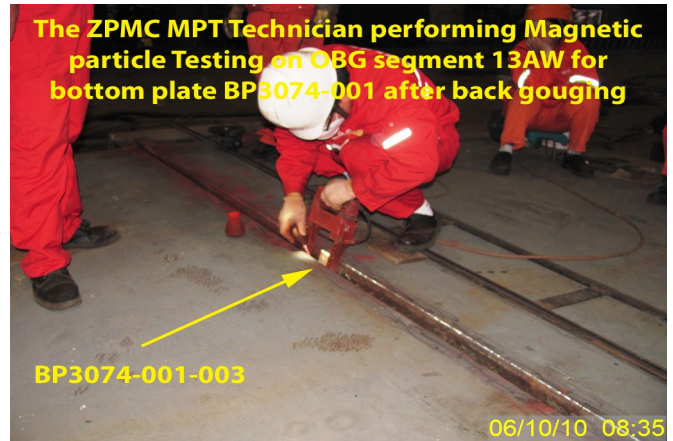
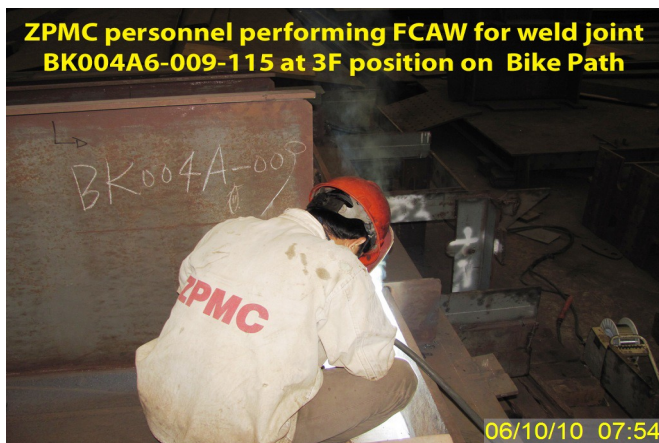
SMAW in the 4G position for the OBG Segment 11BE , weld No. SSD18A-PP100-136. The welder is identified as #047772. ZPMC QC is identified as Mr. Zhong Yong Gang. The welding variables recorded by QC appear to comply with WPS-B-P-2214-Tc-U4b-FCM-1.

FCAW in the 3F position for the OBG Bike Plate , weld No. BK004A6-009-115. The welder is identified as #208641. ZPMC QC is identified as Mr. Zhoe Chang . The welding variables recorded by QC appear to comply with WPS-B-T-2133.

FCAW in the 1G position for the OBG Bike Plate , weld No. BK004A1-008-008. The welder is identified as #062757. ZPMC QC is identified as Mr. Zhoe Chang . The welding variables recorded by QC appear to comply with WPS-B-T-2131-B-U2-F.

SAW in the 1G position for the OBG Segment 13AW bottom Plate, weld No. BP3073-001-004. The welder is identified as #045270. ZPMC QC is identified as Mr. Li Ming Yang. The welding variables recorded by QC appear to comply with WPS-B-T-2221-B-U3c-S-2.

During the Quality Assurance (QA) random in-process visual inspection of Orthotropic Box Girder (OBG) segment 13AW Bottom plate at Bay#16, this QA inspector discovered that the base material was damaged on the Bottom plate due to carbon Arc back gouging. The affected bottom plates are identified as BP3075-001, BP3073-001 and BP3074-001. The material are A709 Grade 345 Non Seismic Performance Critical Member (Non SPCM). The QA inspector informed to ZPMC QC Mr. Li Ming Yang to submit weld repair report before repair the base metal of the bottom plates. OBG bottom plates are located in fabrication Bay 16.

MT was performed on base metal repair locations and area affected by heat straightening on the top plate BKPL1A and BKPL2A of bike path BK4A-003.
